DEPARTMENT OF NATURAL RESOURCES  
DIVISION OF OIL, GAS AND MINING

RE: Site Inspection, U. S. Energy, Velvet Mine, M/037/040, San Juan County, Utah

Date of Inspection: October 7, 2003  
Time of Inspection: 6:20 to 6:35 p.m.  
Conditions: Mostly clear, 50's  
Participants: Paul Baker, DOGM

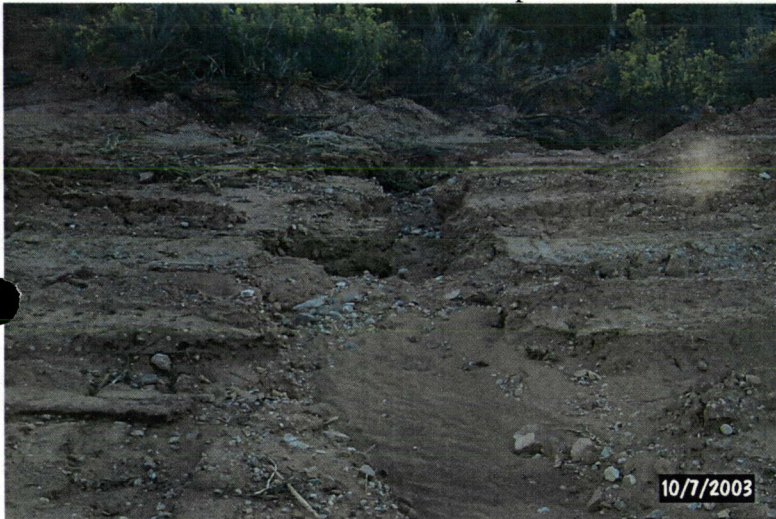
In the ephemeral channel where the culvert was pulled from the road, there had been some erosion through the remaining fill (Photo 1). On the rest of the site, however, there had been very little rilling (Photos 2 and 3). There was sediment in some of the terraces, but considering that the site has no vegetation, it was minimal. A small amount of sediment had made it into the natural drainage just south of the site (Photo 3).

**Photo 1.** The place where the access road crossed a small drainage near the entrance to the mine.

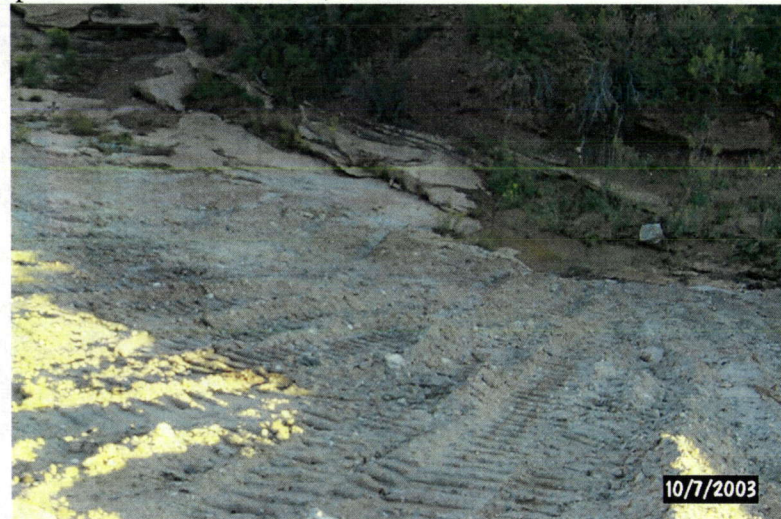
**Photo 3.** The slope leading to the adjacent natural drainage.

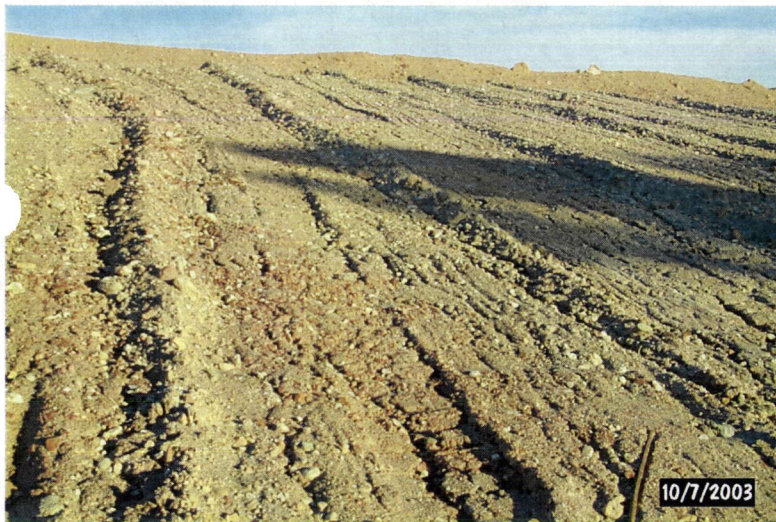
**Photo 2.** One of the slopes on the waste pile. Although there is some rilling, it is minor.

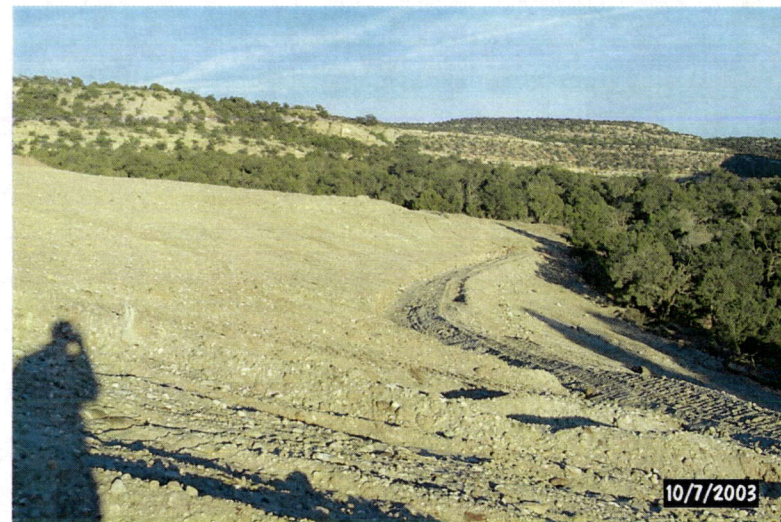
**Photo 4.** The waste rock slope and one of the terraces.

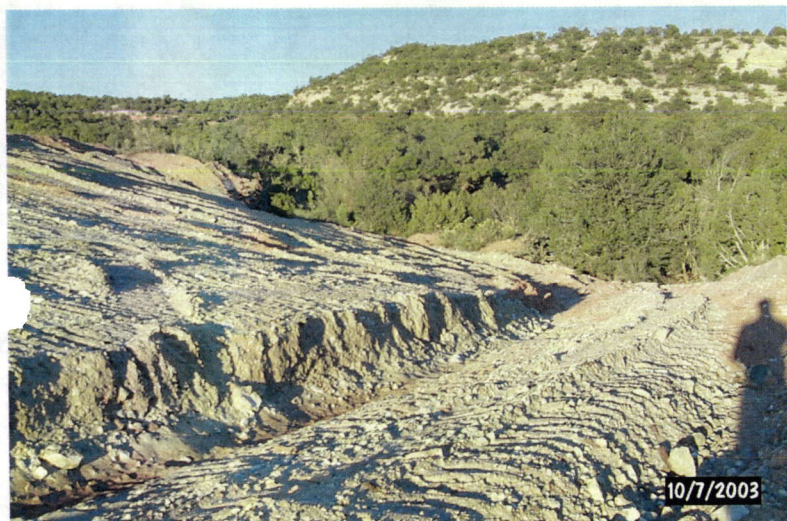
It appears the soil has adequate rock to armor the surface and control erosion. In addition, the terraces reduce the slope length and channel water into natural drainages, and they appear to be functioning properly.

**Photo 5. Another of the terraces. This is sloped to allow water to drain to an adjacent natural drainage.**

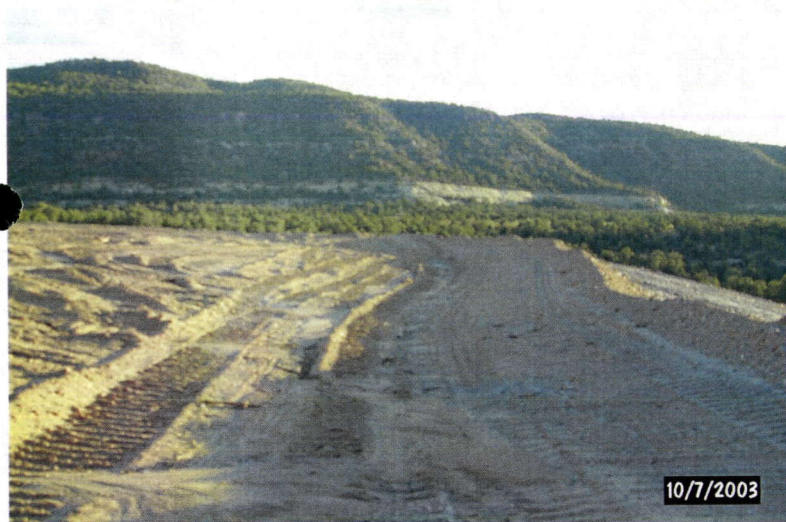
**Photo 6. The top of the waste rock pile. Topsoil was spread in this area, but there was almost no topsoil available for the side slopes.**
